TATA STEEL

Inspection and maintenance guidance

For pre-finished steel building envelopes

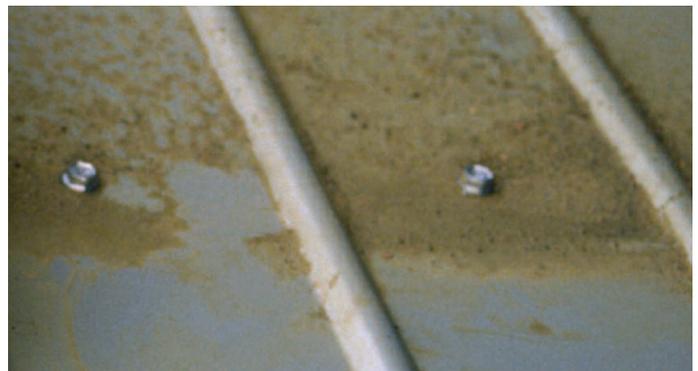
Mould growth on pre-finished steel cladding.

In general, fungi grow as a result of certain conditions, such as the presence of fungal spores, moisture and also of nutrients from various types of dirt. As with dirt and debris, fungal growth will not only affect the appearance, but can also lead to a breakdown of the coating and ultimately result in corrosion of the sheet. Washing the surface can remove fungal growth. A basic solution may be applied to a pre-washed surface by means of a low pressure spray or brush containing:

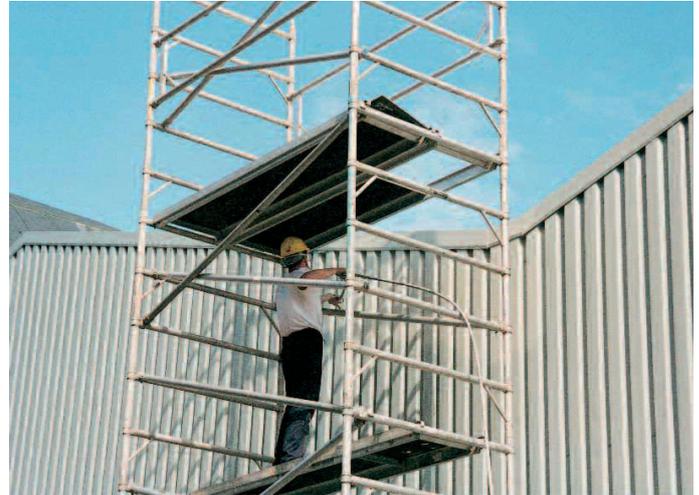
Wall cladding being over-painted.

Caution must be exercised as over-painting is not simply a case of applying proprietary paint to the surface of the cladding. It is important that a compatible coating solution is defined and the use of an approved contractor will ensure correct application. Tata Steel can recommend appropriate over-paint solutions.

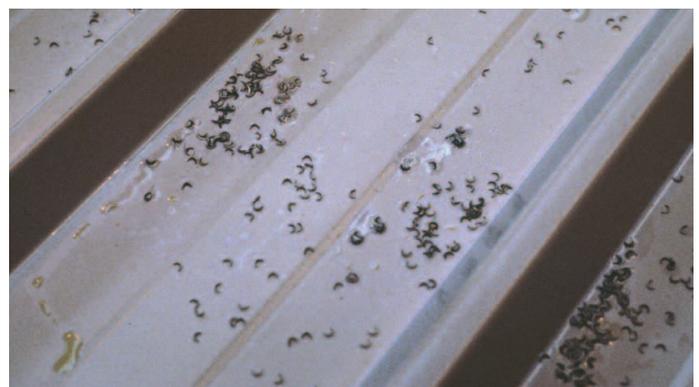
Swarf left on a roof.

Metallic debris, such as swarf, rivet stems or other debris that may remain after construction or modification to the building will be vulnerable to corrosion, leading to an unsightly staining of the cladding. Debris of this nature should simply be removed at as early a stage as possible, carefully so as not to damage the underlying coating.

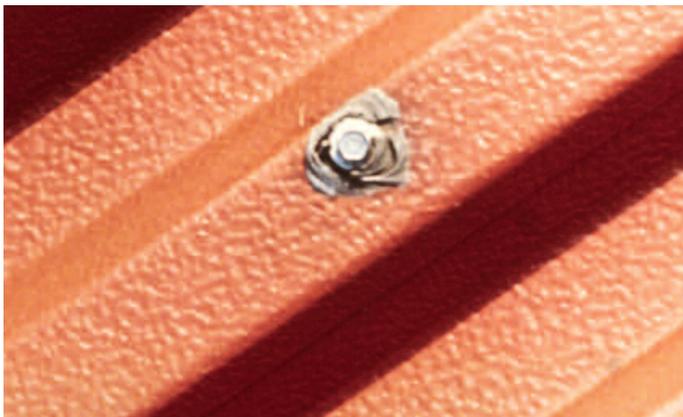
Damaged fastener on roof cladding.

Fasteners which are faulty through damage or corrosion should be removed and replaced. Corrosion can lead to unsightly staining and potential corrosion of the cladding. Caps, if used, should be placed over uncovered fasteners, or replaced if damaged. Inappropriate fasteners of incorrect material or design should also be replaced as again they could lead to corrosion of the panels.

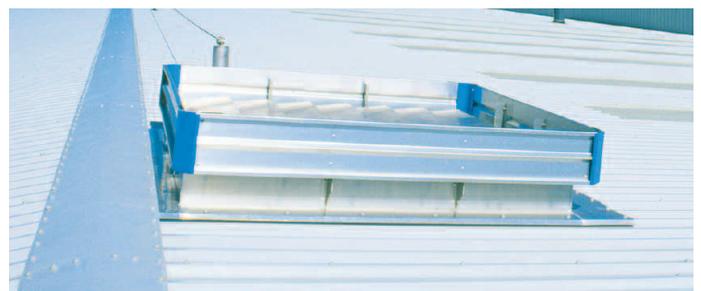
A penetration in roof cladding.

Check around existing penetrations, such as pipe-work and rooflights where the panels have been breached. Clearly, these penetrations have a significant site cut edge and so should be treated as for site cut edges, or sealed using recommended solutions. These areas will be vulnerable to corrosion and ponding, which should be avoided by using the appropriate weather protection.
